Little Bear Fire at Bonito Reservoir and Recovery

October 12, 2023

**CITY OF ALAMOGORDO
UTILITIES DEPARTMENT**

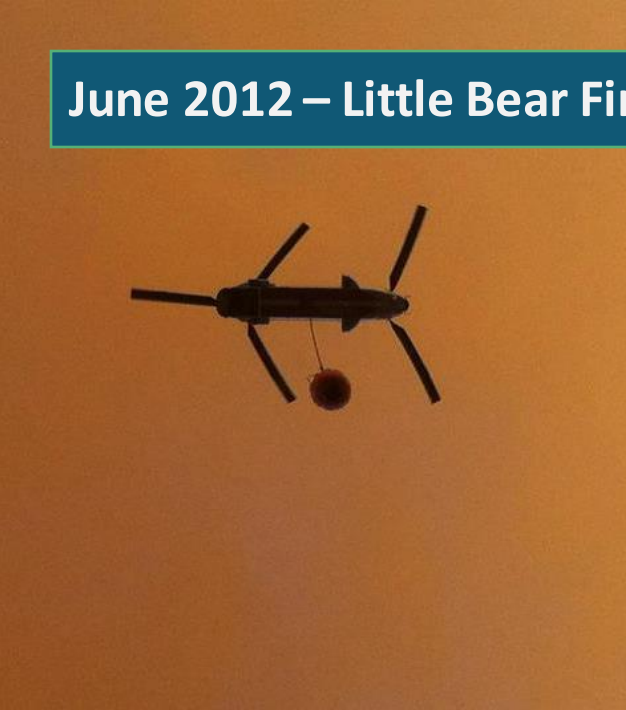
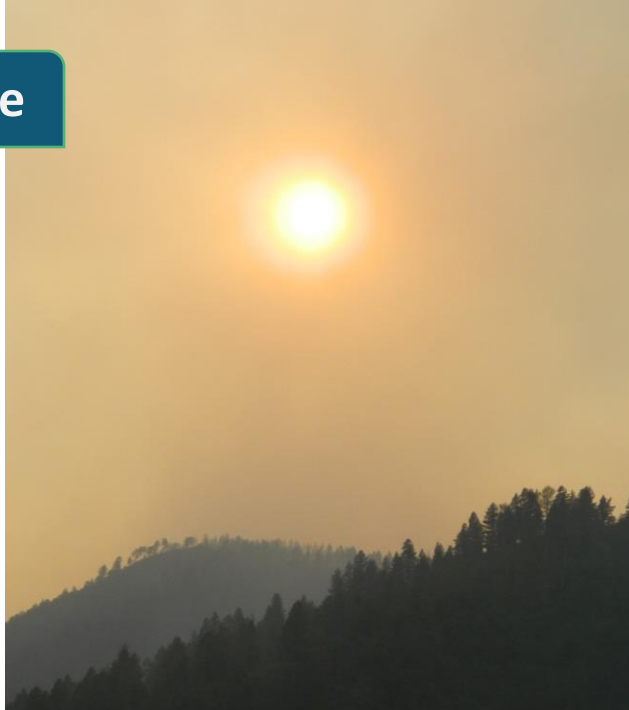
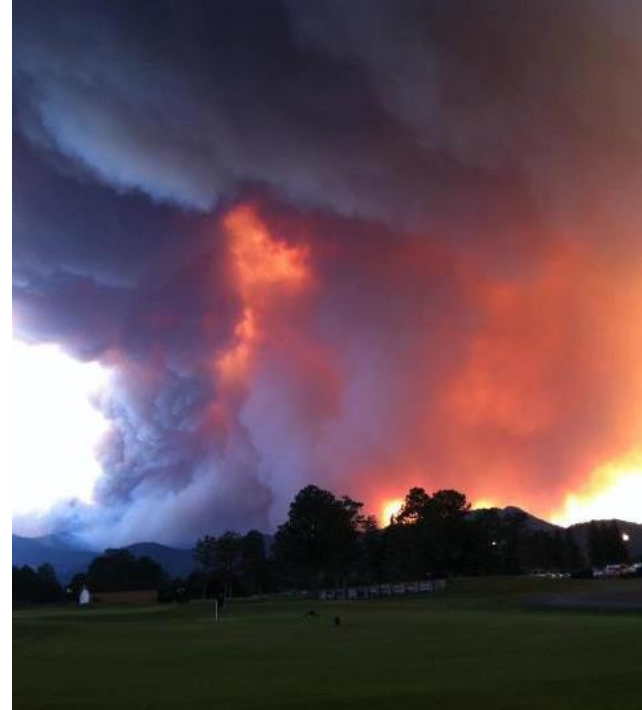
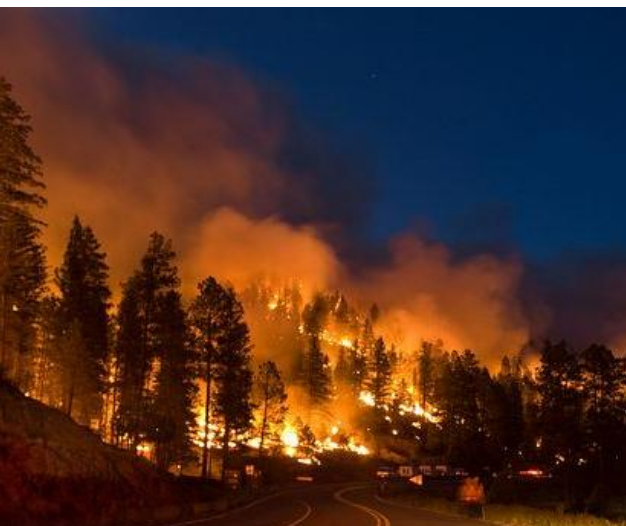
June 2012 – Little Bear Fire

Little Bear fire burned 85% of the Bonito Reservoir water shed

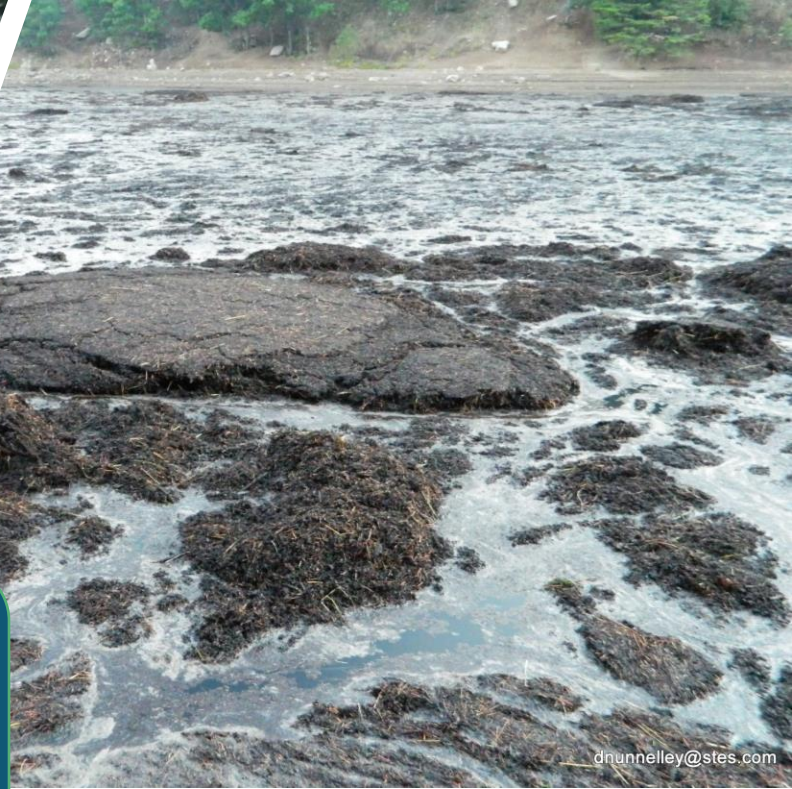
June 22, 2012 – Major storm event #1

The storm created a massive debris flow pushing burned soil, ash, rocks and downed timber into the reservoir. The effects resulted in poor water quality and plugged the outlet works of the Dam.

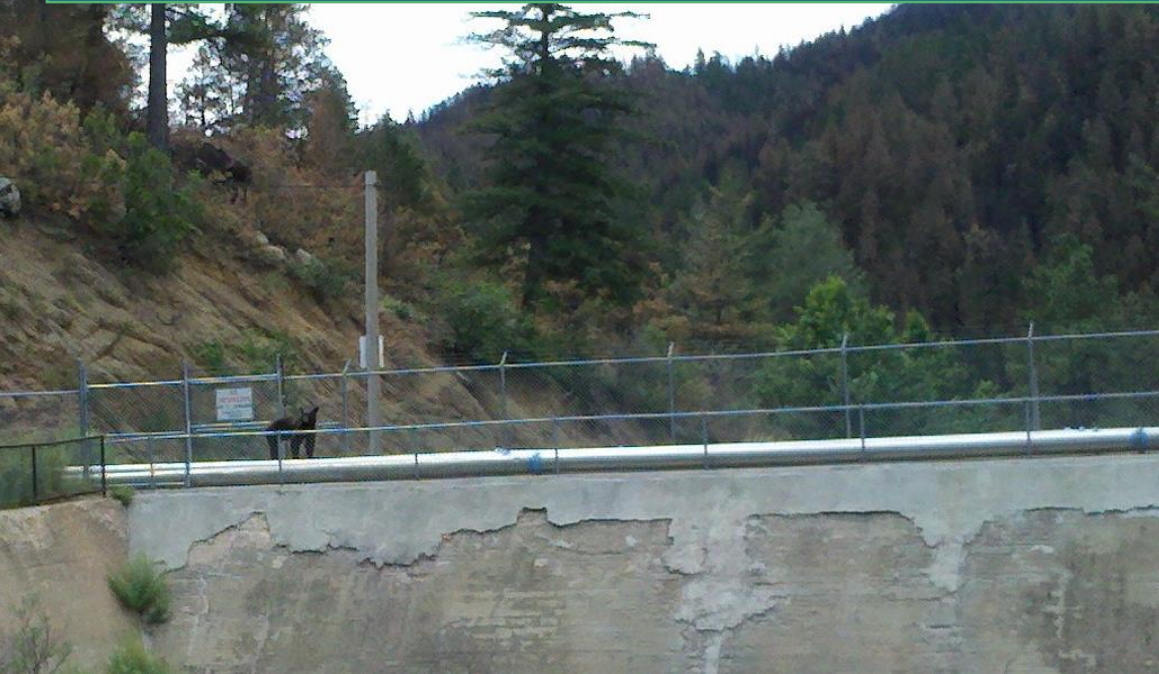
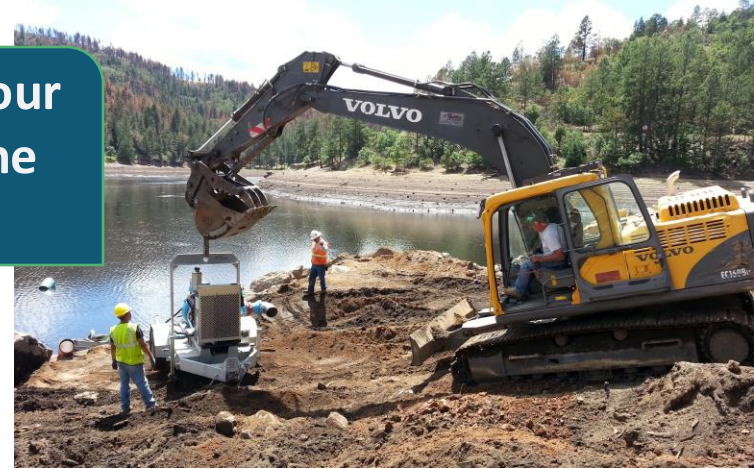
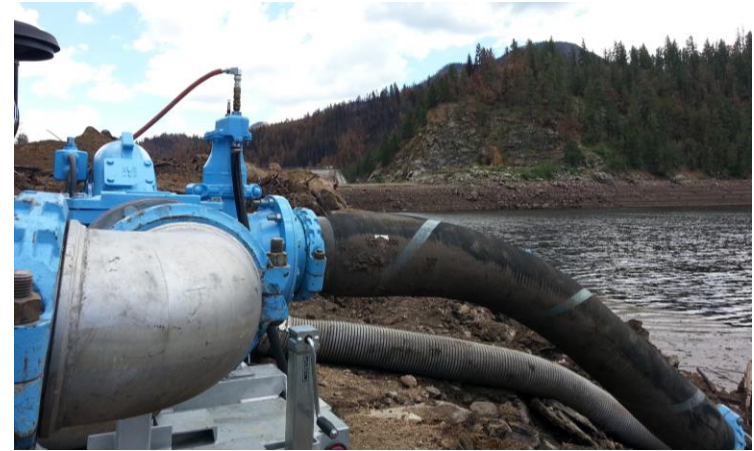
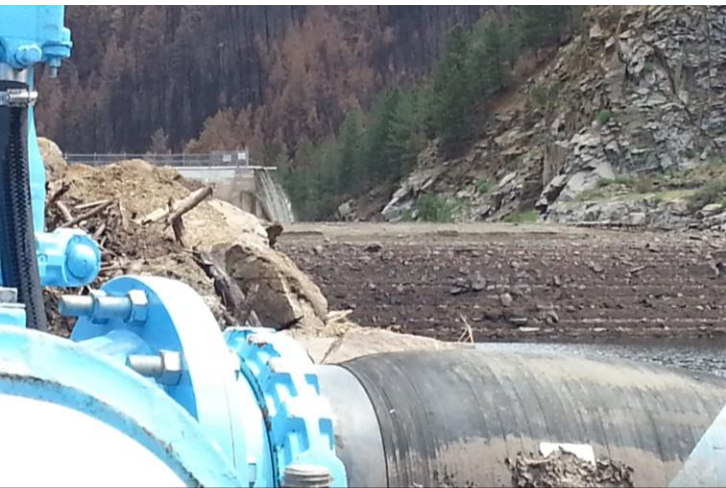
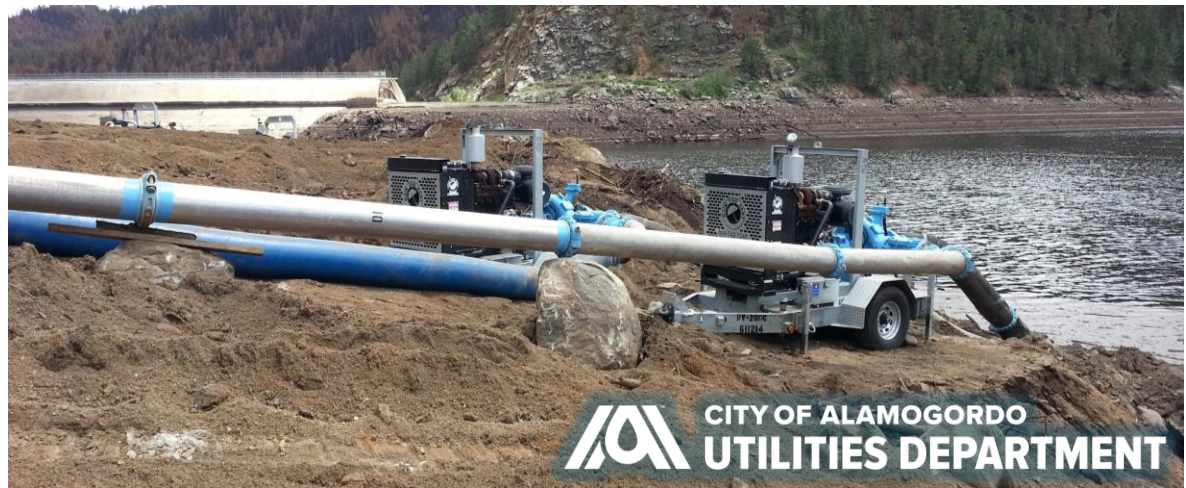
The City of Alamogordo responded by acquiring four 8" pumps to draw down the reservoir to ensure the capacity could handle another debris flow event.

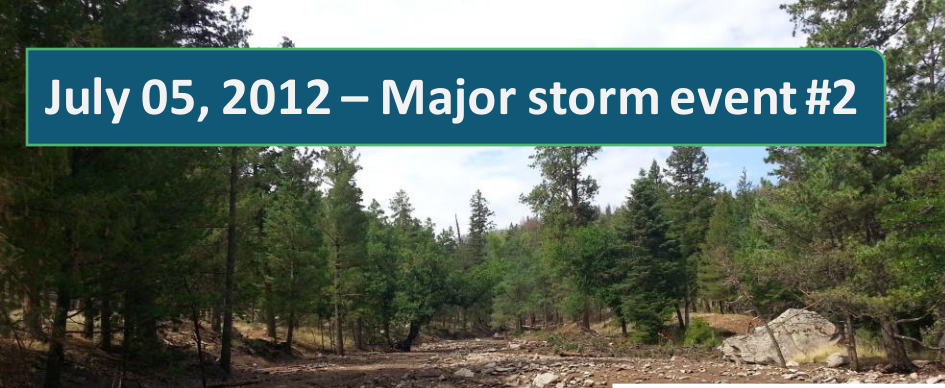
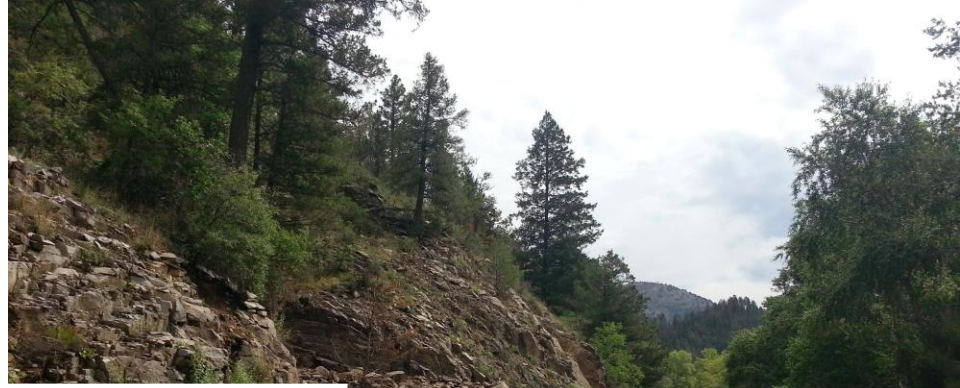
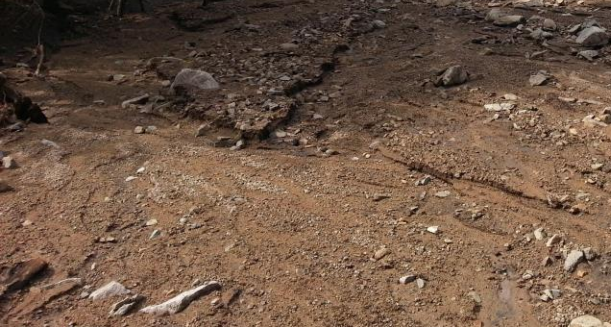
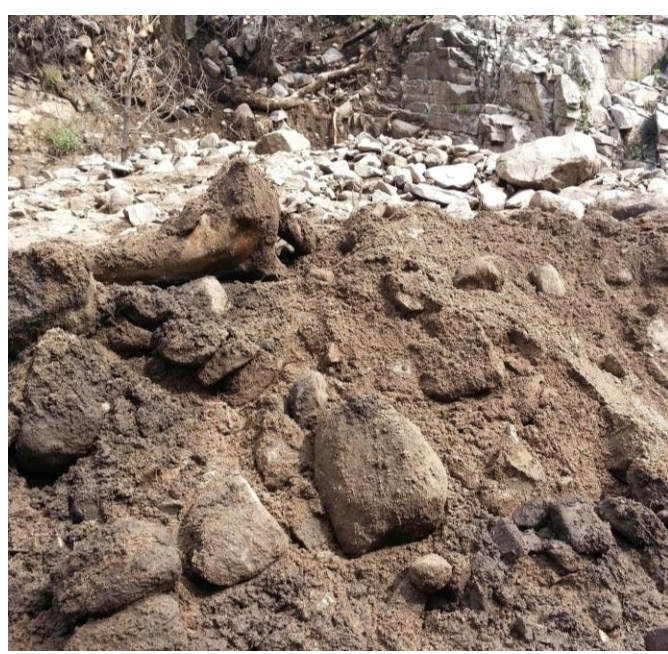
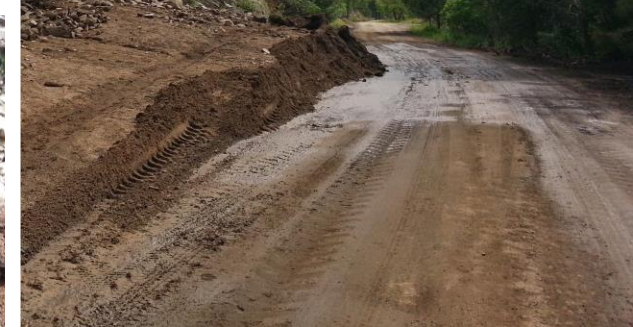
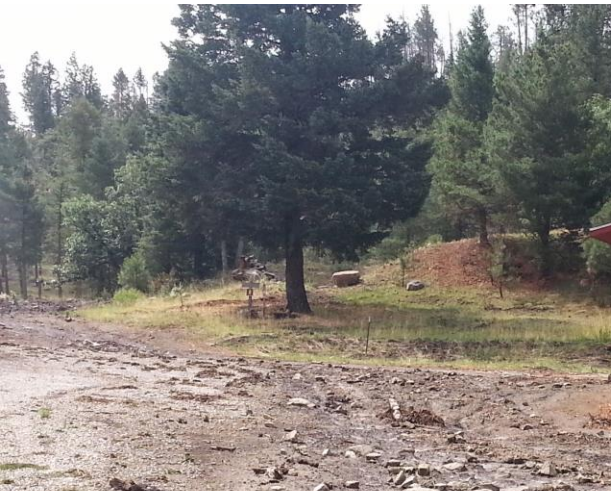
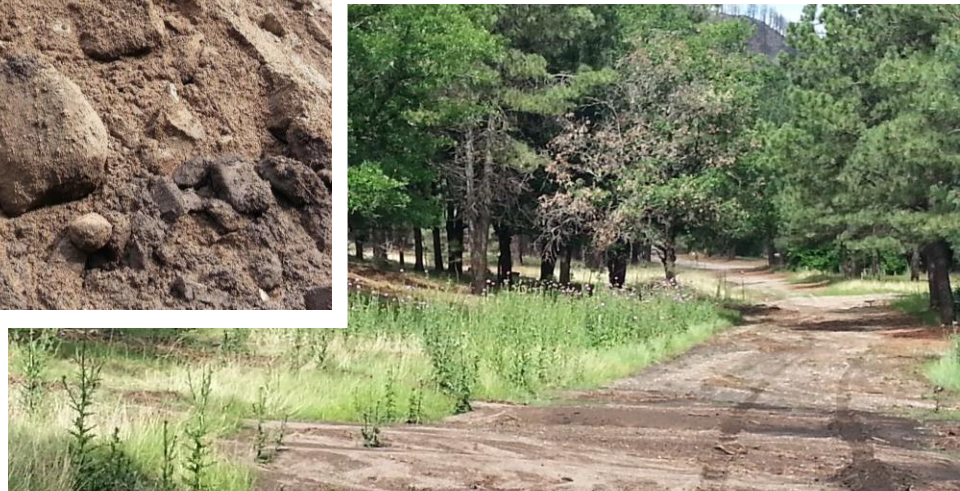
July 05, 2012 – Major storm event #2

This event resulted with additional debris and sediment being deposited into the Bonito Reservoir.
